Air transportation safety investigation report A21P0001

Loss of control

Mooney M20F, C-GYGN

Vicinity of Upper Kananaskis Lake, Alberta

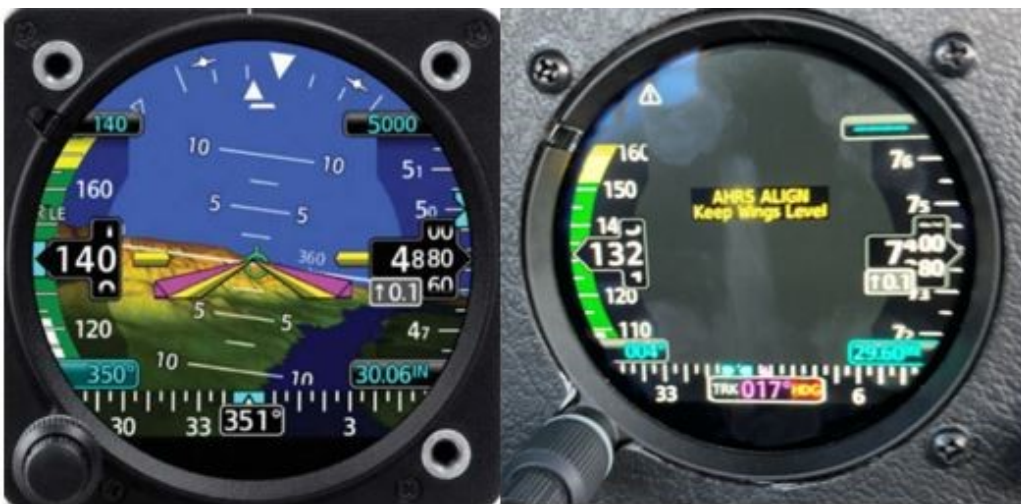
The pilot then requested a minor deviation from the route of flight to avoid entering clouds. However, during this deviation, the clouds could not be avoided, and the aircraft entered instrument meteorological conditions (IMC). Shortly thereafter, the aircraft's attitude direction indicator (ADI) ³ displayed the "AHRS ALIGN" (attitude and heading reference system alignment) message, and indications of attitude (pitch and bank) were lost while indications of airspeed, altitude, and vertical speed were retained (Figure 1).

Figure 1. Garmin GI 275 multi-function instrument configured as an attitude direction indicator. Left image demonstrates a functioning attitude direction indicator (Source: Garmin, *GI 275 Pilot's Guide*, Revision C [2020], p. 175). Right image shows the occurrence aircraft's attitude direction indicator displaying the "AHRS ALIGN" message. (Source: aircraft owner)

The investigation attempted to determine more precisely the source of the initial fault. However, no supplemental information about the instrument, possible reasons it would require realignment while the aircraft was in flight, or analysis of the occurrence aircraft's recorded fault logs were provided to the investigation by Garmin. Therefore, the exact source of the initial fault could not be determined. Nevertheless, based on the information that was available to the investigation, it was determined that the most likely cause of the AHRS ALIGN message on the primary ADI was

either an uncommanded AHRS alignment that took place during the flight or a sensor fault within the AHRS that required the instrument to be realigned once the fault was resolved.
