## ACCIDENT

<b>Aircraft Type and Registration:</b>	HPH Glasflugel 304 eS, G-GSGS	
<b>No &amp; Type of Engines:</b>	1 LZ Design D.O.O FES-HPH-M100 brushless electric motor	
<b>Year of Manufacture:</b>	2016 (Serial no: 059-MS)	
<b>Date &amp; Time (UTC):</b>	10 August 2017 at 1121 hrs	
<b>Location:</b>	Parham Airfield, West Sussex	
<b>Type of Flight:</b>	Private	
<b>Persons on Board:</b>	Crew - 1	Passengers - None
<b>Injuries:</b>	Crew - None	Passengers - N/A
<b>Nature of Damage:</b>	Fire damage to FES <sup>1</sup> batteries and FES battery compartment	
<b>Commander's Licence:</b>	British Gliding Association Gliding Certificate	
<b>Commander's Age:</b>	55 years	
<b>Commander's Flying Experience:</b>	314 hours (of which 25 were on type) Last 90 days - 9 hours Last 28 days - 7 hours	
<b>Information Source:</b>	AAIB Field Investigation

## Synopsis

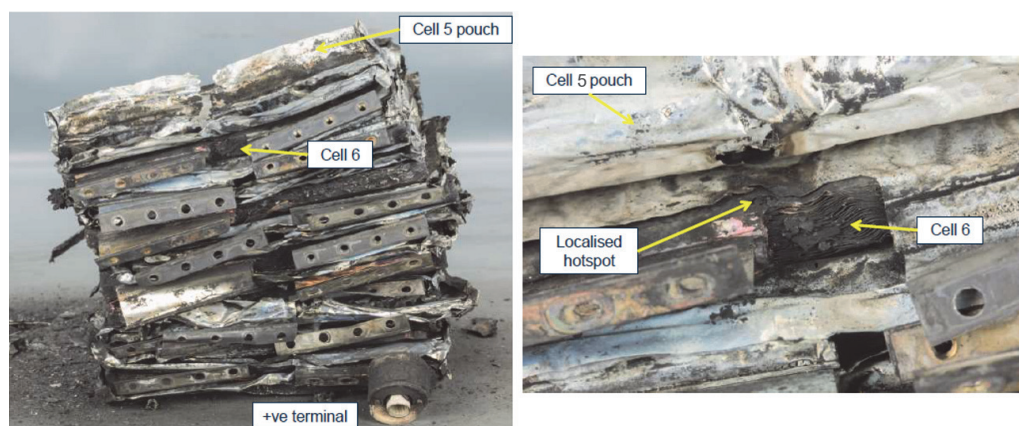
**Figure 8**

Localised hot-spot between cells 5 and 6 (courtesy QinetiQ)

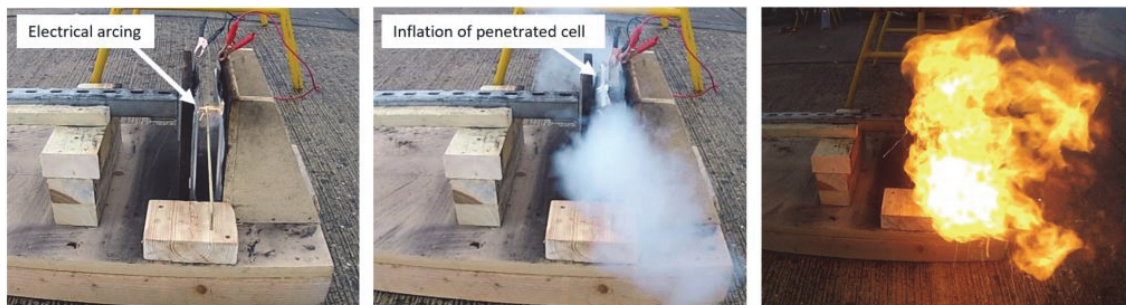
**Figure 12**

The electrical arcing was immediately followed by rapid inflation of the cell pouch and the ejection of light grey smoke, followed shortly by flames. The fire continued for approximately two minutes until the gel electrolyte polymer, which was the main fuel source involved in the fire, was fully consumed.

Electrical arcing following cell penetration

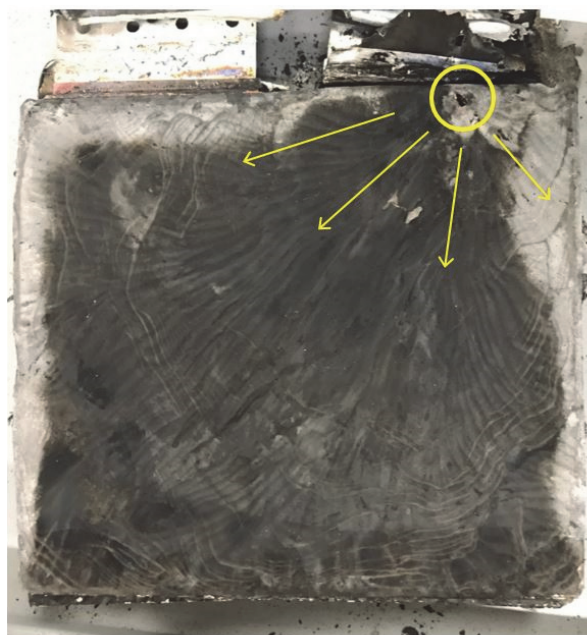
**Figure 13**

Examination of the steel nail after the tests showed that it had melted in the initial electrical arcing event, indicating that the temperature generated during the arcing was in excess of 1,400°C. The cell electrodes at the penetration site had a hole of larger size than the nail diameter, the edges of which were formed from solidified molten electrode material, consistent with the melting of the electrodes during the arcing event. The remaining copper and aluminium electrodes were relatively intact, demonstrating that the temperature reached during the combustion of the cell's gel electrolyte was relatively cool compared to the electrical arcing temperature. A pattern of combustion 'beachmarks' originating at the nail penetration site was observed (Figure 13) these were similar to those observed in the fire-damaged battery from G-GSGS.

Combustion beachmarks from AAIB cell penetration tests

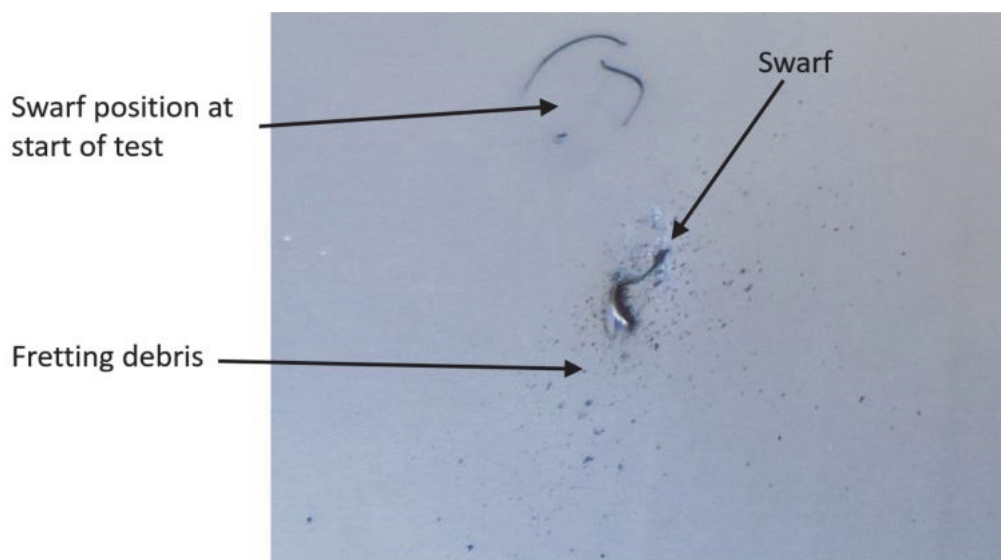
**Figure 16**

A second test was conducted with 3.0 mm lengths of steel swarf inserted between the cells (Figure 16). The cells were vibrated in the horizontal axis for 30 minutes at a resonant frequency of 20 Hz, during which there were no signs of fire, smoke or unusual odours. Following this test, the cell fixture was disassembled and it was noted that there had been migration of the swarf within the cell fixture and some fretting of the cell pouch material due to contact with the swarf, but the fretting depth had not exceeded the pouch thickness and no electrolyte had been released.

Cell pouch fretting during vibration testing with metal swarf present

The vibration testing conducted by the AAIB showed that whilst cell pouch fretting did occur due to the presence of swarf within a battery assembly, the fretting was not severe enough to cause the swarf to penetrate the cell pouch and cause an internal short circuit within a cell.
