This Airworthiness Bulletin (AWB) is a compilation of information contained in Airworthiness Advisory Circulars (AAC), Service Bulletins (SB), Service Difficulty Reports (SDR) and Advisory Circulars (AC) and will be revised from time to time to incorporate new magneto defects.

Magneto Defects

AWB 74-005 Issue : 3
Date : 20 October 2014

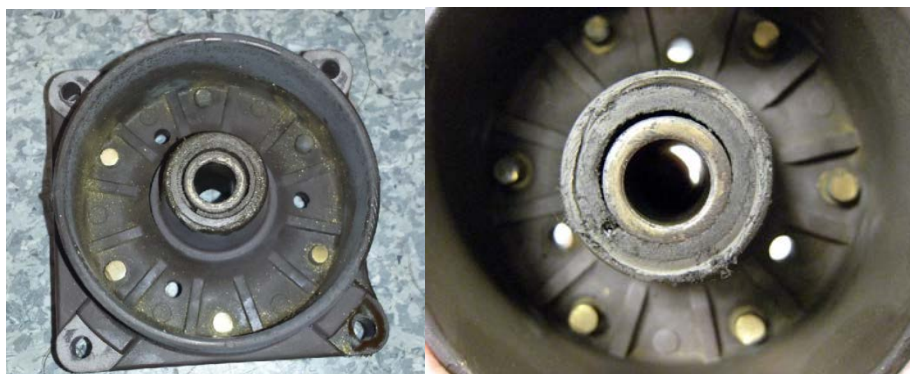
Figure 5 – Distributor Bearing block

Magneto miss-firing and dead-cuts have been traced to the distributor wheel shaft bearing spinning and moving in the bearing block. 30 SDRs have been reported regarding this type of failure. On one occasion this problem caused an engine failure on take-off.

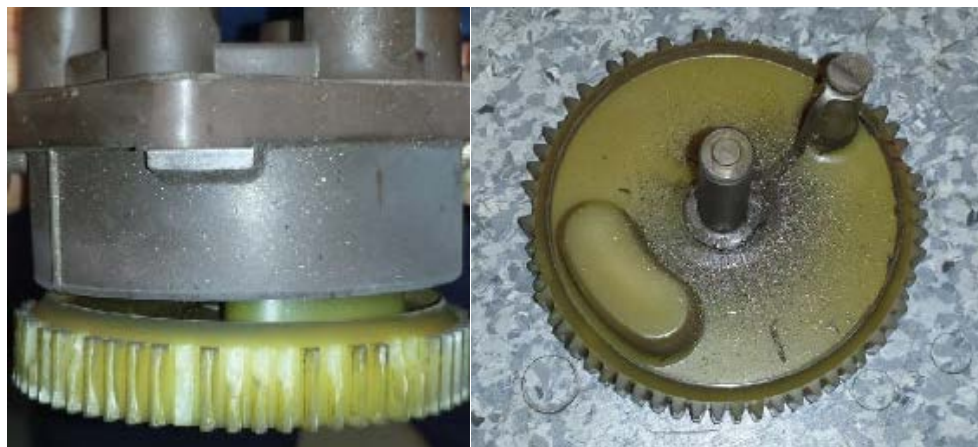
Figure 7 - Sheared teeth and debris from electrode contacting high tension terminals

Lower bearings have been found loose in the cap has also allowed the electrode on the rotor finger to contact the high tension terminals in the cap (see Figure 7). This type of failure could cause premature magneto failure.

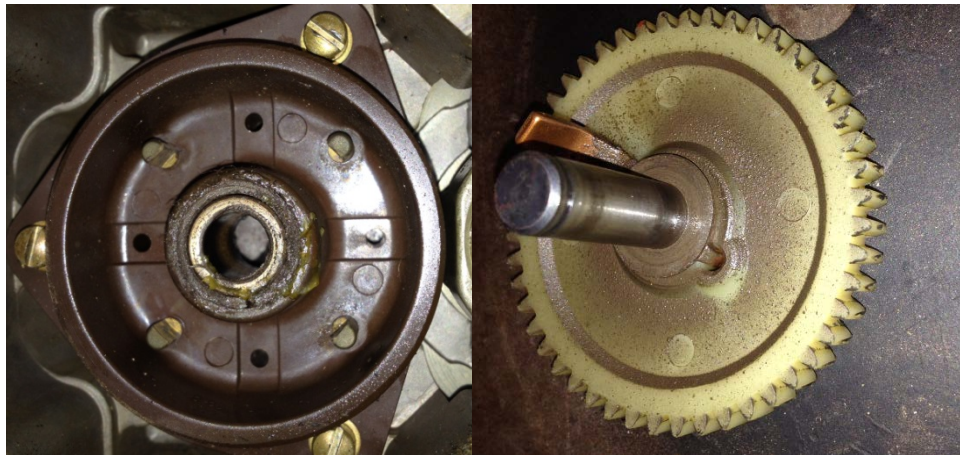
Figure 8 - Bushing failure

It is reported by magneto overhaul shops that despite close inspection of new distributor blocks, there is no way to determine if a new distributor block will prove to be reliable in service. This is currently the matter of an active on-going investigation in conjunction with manufacturers. In the CASA SDR database, there has been an approximately 70% increase in loose distributor block bearings in rotorcraft installations.

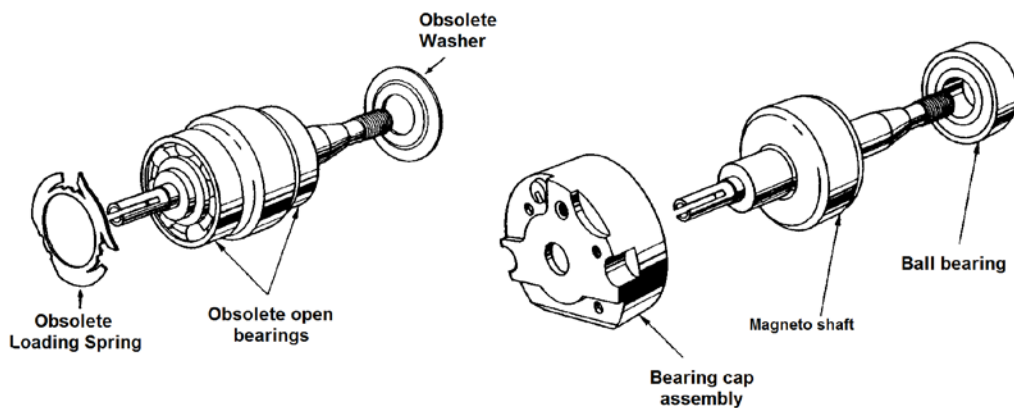
Figure 9 - Old and new slick bearing end cap designs

CASA AAC 1-81 - Magneto Maintenance - General 6/95 documented bearings spinning in the end cap. This has occurred in Slick 4200 and 6200 series magnetos and AD/ELECT/46 was issued to address this problem. The AD has been cancelled and the content of which is now incorporated into manufacturers Service Bulletins see Figure 9 below.

Several incidents have occurred in Slick 4300 and 6300 series magnetos describing magneto shaft bearings spinning in the end cap. Champion Aerospace have advised that the bearing spin incidents could occur under abnormally high temperature environments with high vibration and/or high

bearing side loading caused by misalignment of the engine drive gearing. Champion Aerospace supplies the bearings with the end cap as a replacement part; which eliminates the need to press in new bearings thus reducing the possibility of bearing spin due to improper assembly.

This problem was addressed with the end cap bore diameter being changed to provide an improved interface with the bearing. Champion Aerospace has also advised that tolerances have been tightened even further on the bearing and end cap and replacing the bearing only may cause the bearing to spin in the end cap. Bearings supplied without the end cap are not approved spares and should not be used.

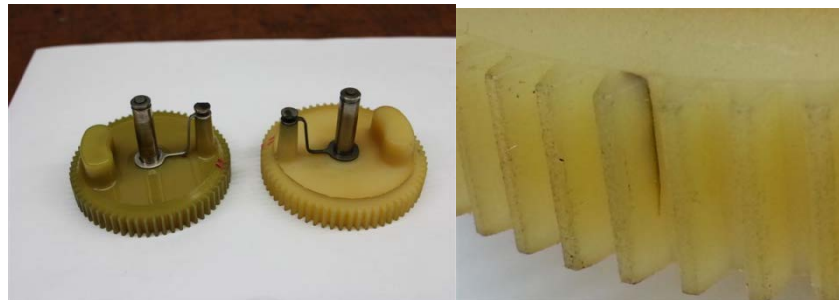
Figure 11 - Original gear compared to sandblasted gear and cracked gear tooth

A closer inspection of the sand-blasted gear tooth revealed cracks, which would have caused an eventual premature failure of the gear.

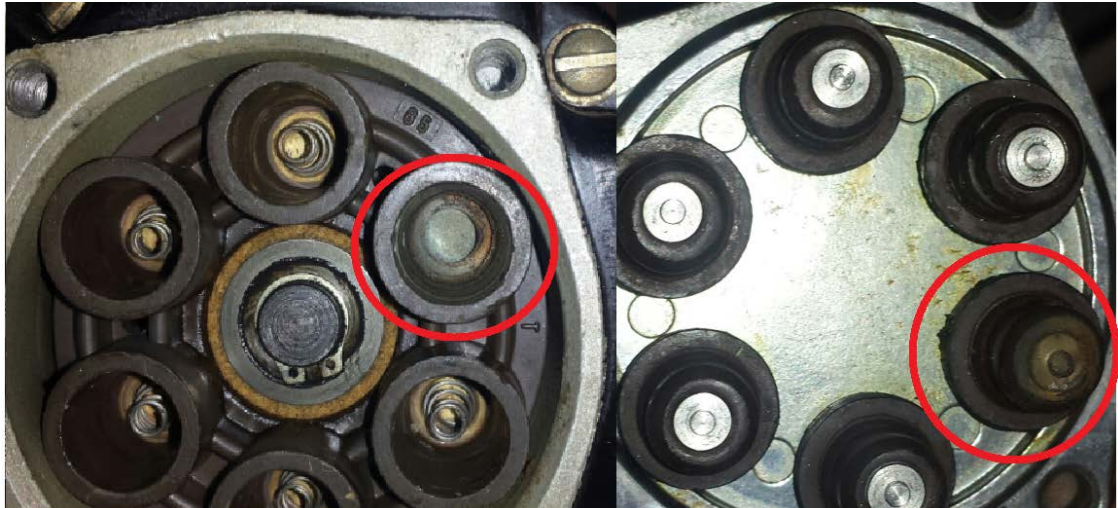
Figure 12 - Missing block spring

Figure 12 shows both sides of the magneto distributor block where a distributor block spring was missing in the assembly of the magneto.

This magneto in the engine of rotorcraft, failed in service because a missing spring caused misfiring which lead to an autorotation landing. If the spring is missing it causes intermittent cross firing in the distributor and loss of power. It is important to check the springs are serviceable whenever an opportunity presents itself.

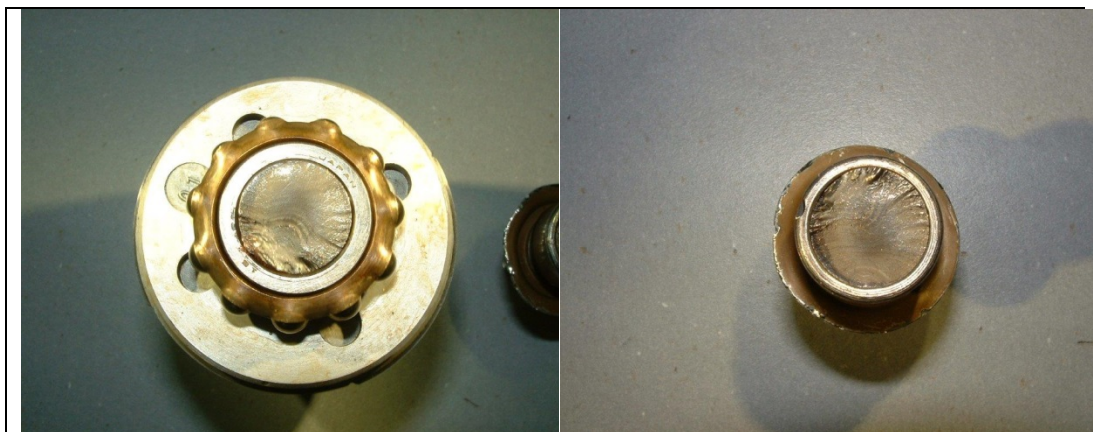
Figure 13 - Sheared shaft

Failures of the type indicated in Figure 13 appear to be a result of high cycle fatigue cracking which initiates from small corrosion pits in the shaft or in the area of the Woodruff key. This shaft can also respond to engine vibration which, under certain conditions may induce a bending or wave motion response typical of shafts rotating at critical whirl speed, making the shafts vulnerable to any surface defect.

Failures of this kind may also be linked to the same possible causal factors listed in as detailed in paragraph on Broken Distributor Gear Teeth.

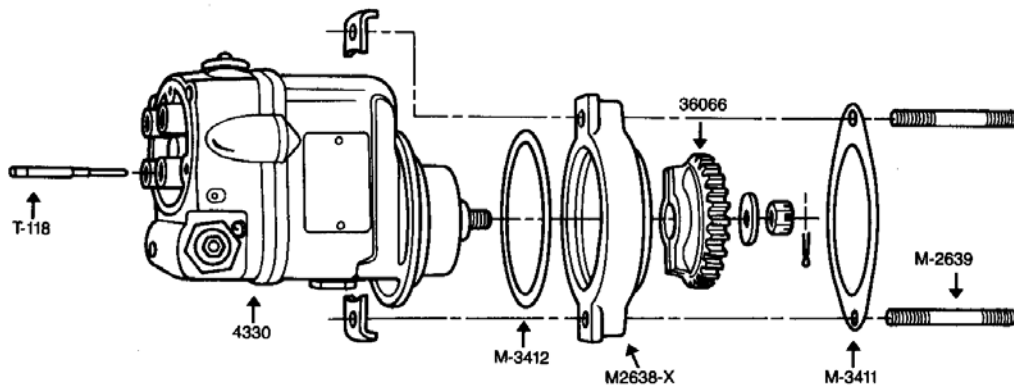
Figure 14 - Extract from SL1-93

According to the A&P mechanic who repaired the aircraft, the failure was caused by the installation of an incorrect gasket which did not provide proper support for the mounting flange, causing the flange to fail. It is thought that the thickness of the gasket had a bearing on the failure. The aircraft's remaining magnetos were inspected and were also found to have incorrect gaskets installed and, although two of the magnetos were cracked, none had progressed to failure. This particular magneto application calls for the installation of two Lycoming gaskets (P/N 62224), one on each side of the adapter plate see Figure 14. The failed magneto on this aircraft had one P/N 62224 gasket between the adapter and the engine case, but had an LW 12681 gasket, and possibly a TCM P/N 534750 gasket, between the magneto and the adapter plate, which is incorrect.

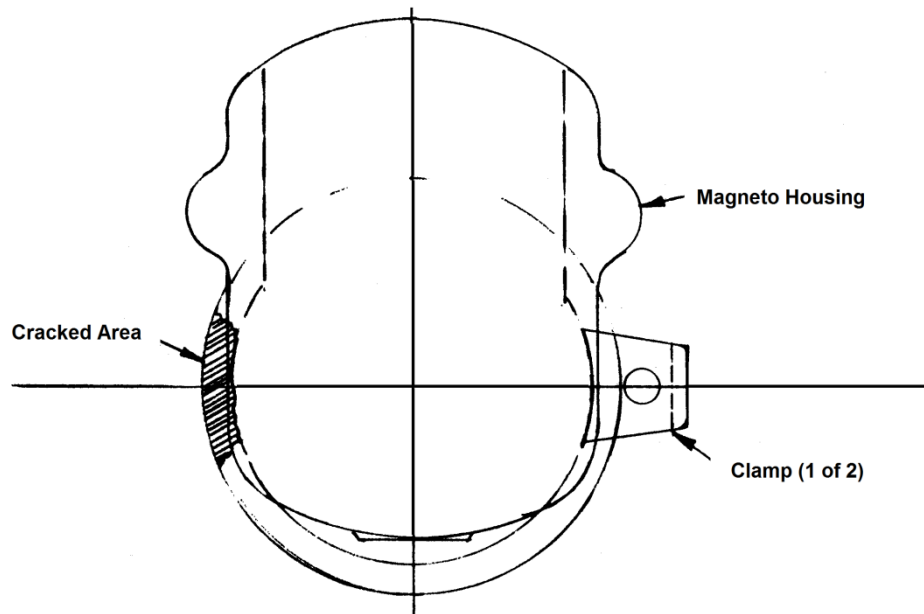
Figure 15 - From Slick SB 3-80B Broken Magneto flanges

An SDR was submitted to CASA where a manufacturing defect was identified in the housing casting. Failure occurred at the point of contact with the hardware. This caused the separation of a large portion of the flange from the housing.

LAMEs are reminded that extra precautions should be taken when new parts are drawn from stores and used during re-installation. The gaskets were all authentic Bendix magneto gaskets. It was their particular application that was faulty in these instances." Note in Bendix SB 3-80B, Bendix attributes broken magneto attachment flanges to over-torquing the attachment flange nuts.

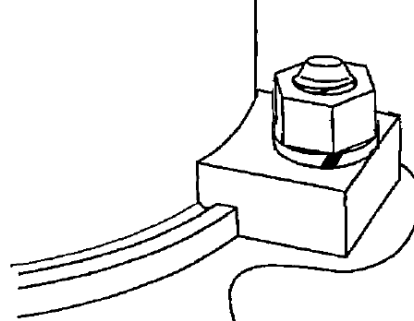
Figure 16 - Adapted from Slick SL3-92C

Over torquing has also been attributed to distributor block cracks (SDR 510018733).

Example of over-torqued magneto gaskets has been reported to CASA. As a result the gaskets perished in service. Gaskets should not be re-used and the approved data documentation should be followed.

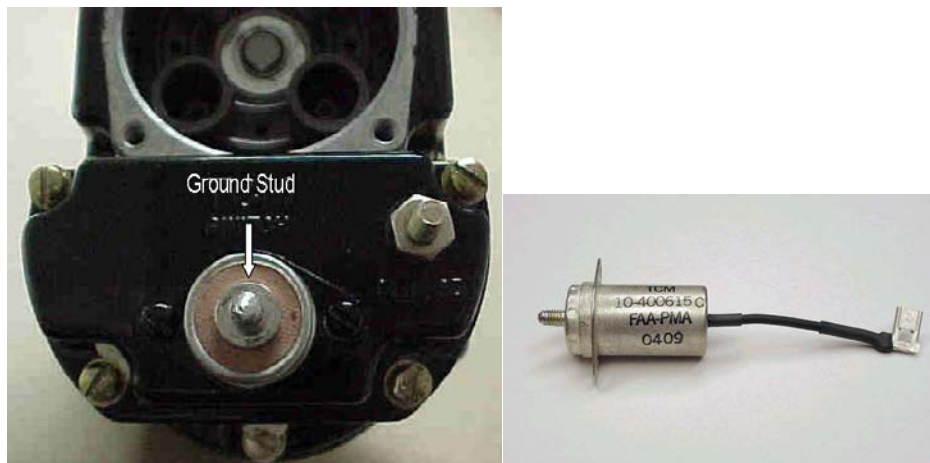
Figure 17 - Capacitor

Teledyne Continental Motors has identified a quantity of particular magneto capacitors which may have ground stud (also referred to as the P-Lead stud) threads that do not meet specification. This may allow the ground wire (P-Lead) to come loose, resulting in a hot (live) magneto. A list of affected magnetos and capacitors are listed in the service bulletin.

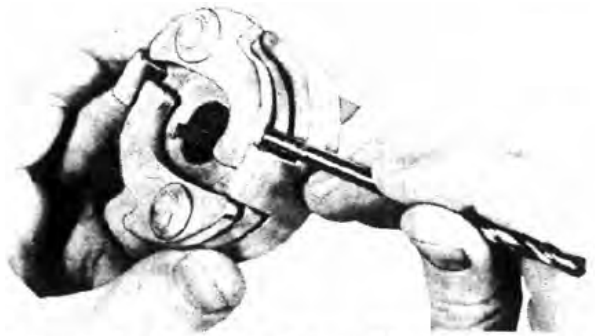
Figure 18 - Checking clearance between flyweights and cam

Engines have been extensively damaged and suffered complete in-flight engine failure due to Bendix magneto coupling failures. Flyweight axles and axle holes may become worn, allowing the tip of the flyweight to contact the magneto housing. If the wear is not checked correctly a worn pawl axle can allow the tip of the flyweight to machine the mounting flange off the magneto allowing the magneto to detach from the engine in flight. These incidents have highlighted an apparent misconception concerning the most satisfactory way to check impulse coupling component wear.

Bendix recommends the use of a drill shank to make a clearance check between the flyweights and cam of the coupling, but the instructions of this bulletin are in no way intended to replace Bendix service and overhaul manuals.

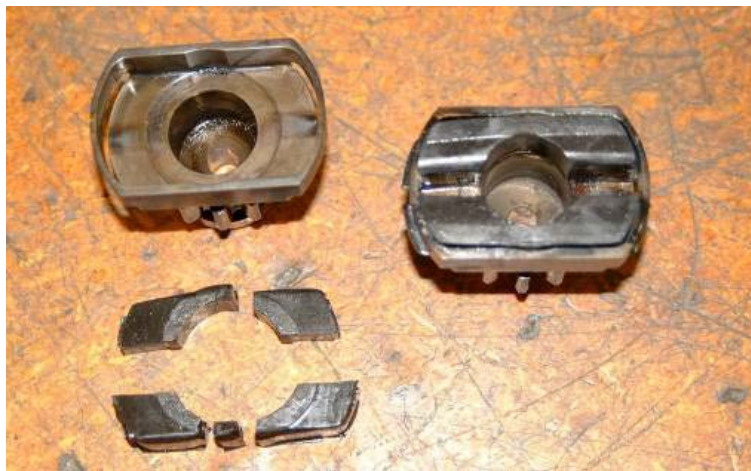
Figure 25 - Failed magneto drive rubbers

Although the magneto drive rubbers or cushions become hard and brittle during normal operation, it has been found that abnormal torsional engine vibration may cause magneto drive rubbers to fragment.

The study found that torsional vibration from the engine crankshaft was transmitted through the accessory gears to the EDFP coupling and to the magneto coupling. Torsional vibration caused the left hand magneto drive damper within the coupling to fail as illustrated in Figure 25(above). Similar failures of both EDFP couplings and magneto drive rubbers have also been reported in Australia. In the resulting post-study engine overhaul, the cause of EDFP coupling failure was attributed to worn crankshaft counterweight damper rollers and bushes.
