Accident to the ROBIN - DR400- 120 registered F-GSBK

on 3 September 2018
at Bénodet (Finistère)

Failure of an engine cylinder en route, forced landing, overturn during landing run on beach

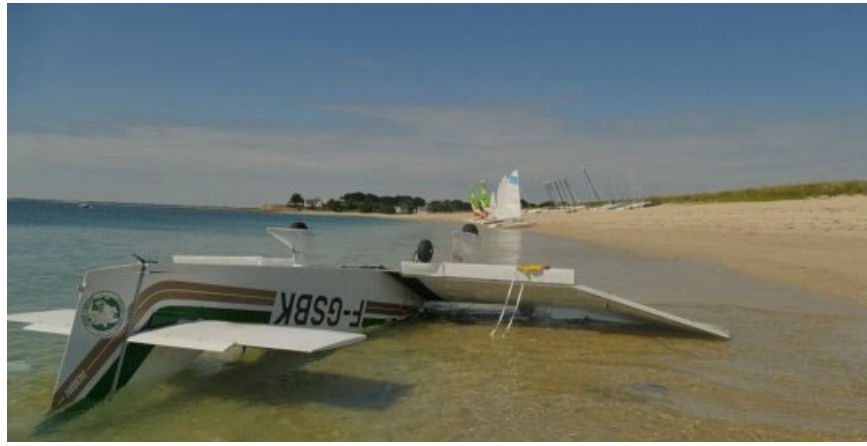
The pilot, accompanied by two passengers, took off from Quimper Pluguffan aerodrome (Finistère) for a local flight to the Glénan islands situated at around 17 NM south-south-east of the aerodrome. The pilot descended to a height of around 500 ft above the sea so that the passengers could take photos of the group of islands. He then wanted to gain altitude but his input on the power level had no effect. The engine started to vibrate, oil was splashed onto the canopy and smoke escaped from the engine cowling. The pilot could not find an area on the islands suitable for a forced landing. He turned back towards the mainland and made an emergency call. The residual engine power permitted the pilot to hold speed and level flight at an altitude of 500 ft. He configured the plane for an east-facing landing⁽²⁾ on a beach. The engine shut down and the propeller locked before the turn east to align with the axis of the beach. The presence of a person on the beach made the pilot alter his path to the right and approach the edge of the water. On landing, the aeroplane turned over onto its back and came to a stop in the water.

Figure 1: Photo of F-GSBK at end of emergency landing

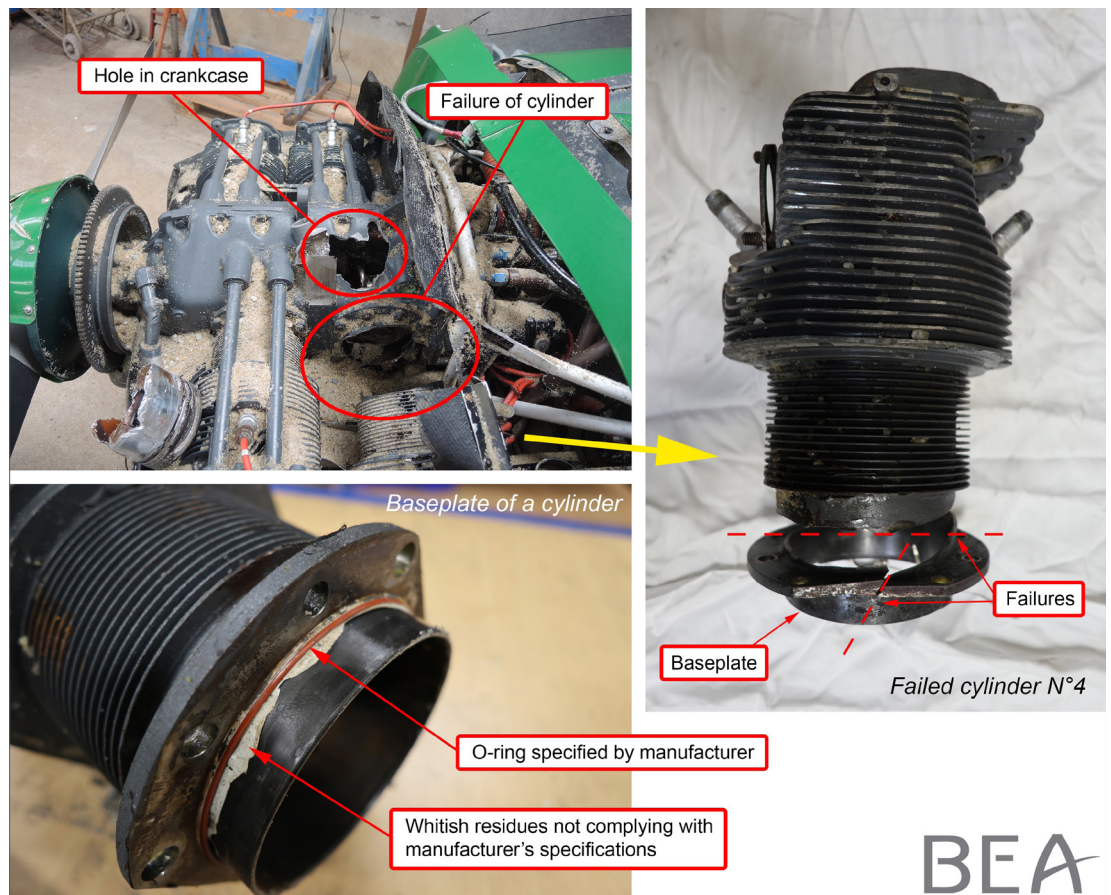
The crankcase was perforated in line with cylinder No 4, on the rear left side of the engine. Cylinder No 4 had failed on all of the circumference of its steel barrel⁽³⁾ in immediate proximity to its base plate still attached to the engine. This base plate had also failed radially. There was no top coat paint in line with this break and superficial corrosion was found on the surface. The outer surface of the three other cylinders also had superficial corrosion instead of paint.

Figure 2: Photos of engine and cylinder No 4

The rod of cylinder No 4 was not found. There was a large amount of damage on its piston. The disassembly of the engine did not reveal any sign of unusual lubrication which could explain the premature failure of the engine. There was no significant damage on the crankshaft and inside the cylinder. The separation of the “rod and piston” assembly of cylinder No 4 thus seemed to be the consequence of the failure of this cylinder.

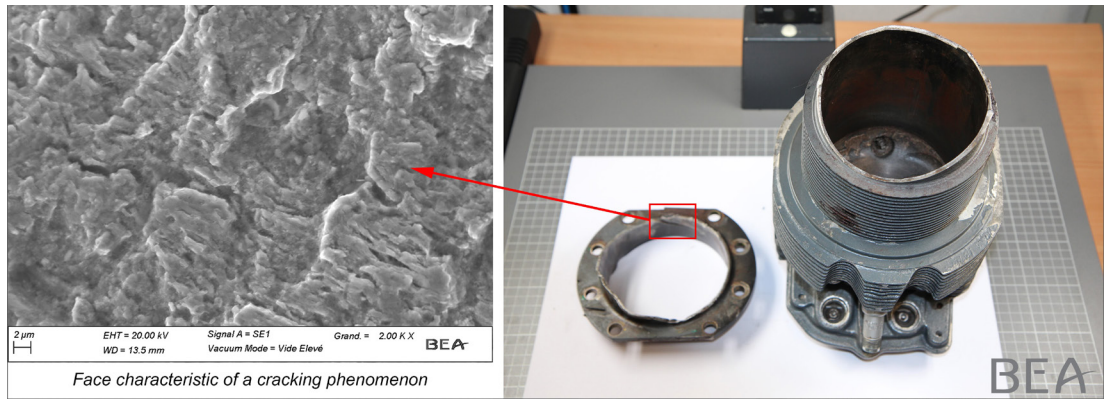
The detailed examination of cylinder No 4 revealed that this failure was the result of a fatigue cracking phenomenon in the steel barrel of the cylinder. The fracture was damaged with peening over a large part of its face⁽⁵⁾. This advanced state of damage meant that it was not possible to identify the incipient crack site(s) or the exact dimension of the crack on the circumference of the cylinder. Nevertheless, the presence of indications of crack formation in at least two distinct areas of the fracture along with the peened and oxidized appearance of the face seem to indicate a cracking process which progressively developed over time, without it being possible to define when it started.

⁽⁵⁾ During the cracking process, the pressure of the surfaces pressing against each other results in their superficial compression which can obliterate all or some of the crack formation indications.

Figure 3: Examination of cylinder No 4
