DAHER AEROSPACE

SB 10-157

SERVICE BULLETIN

SUBJECT: MAIN LANDING GEAR LOCKING

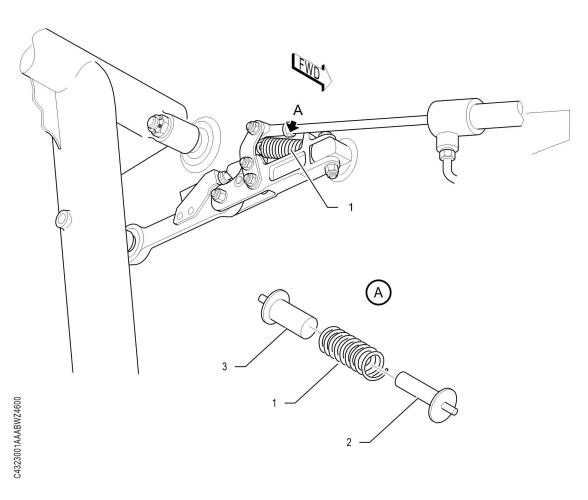
Figure 1 - Spring and guides - Removal / Installation

Main landing gear may not lock properly which is indicated by a missing green light on the control panel.

Corrosion of the strut lock spring guides.

2) Inspect the three removed parts.

1) Using any appropriate means, compress and remove the assembly spring pin guide (2) / spring (1) / spring socket guide (3).

3) Apply a thin coat of grease AIR 4210B — MIL—PRF—23827C (Type II) or equivalent on spring pin guide (2) external face and spring socket guide (3) internal face.

4) Reinstall spring pin guide (2), spring (1) and spring socket guide (3).

- 3) Discard spring pin guide (2), spring (1) and spring socket guide (3) previously removed.
- 4) Apply a thin coat of grease AIR 4210B MIL-PRF-23827C (Type II) or equivalent on spring pin guide (2) external face and spring socket guide (3) internal face.

5) Install spring pin guide (2), spring (1) and spring socket guide (3).
