ACCIDENT

Aircraft Type and Registration:	DA 40 NG, G-CTSB
No & Type of Engines:	1 Austro E4-A piston engine
Year of Manufacture:	2015 (Serial no: 40.N283)
Date & Time (UTC):	12 December 2020 at 0926 hrs
Location:	Cranfield Airport, Bedfordshire
Type of Flight:	Aerial Work
Persons on Board:	Crew - 1 Passengers - None
Injuries:	Crew - 1 (Serious) Passengers - N/A
Nature of Damage:	Aircraft destroyed
Commander's Licence:	Commercial Pilot's Licence
Commander's Age:	23 years
Commander's Flying Experience:	1,229 hours (of which 779 were on type) Last 90 days - 70 hours Last 28 days - 33 hours
Information Source:	AAIB Field Investigation

Synopsis

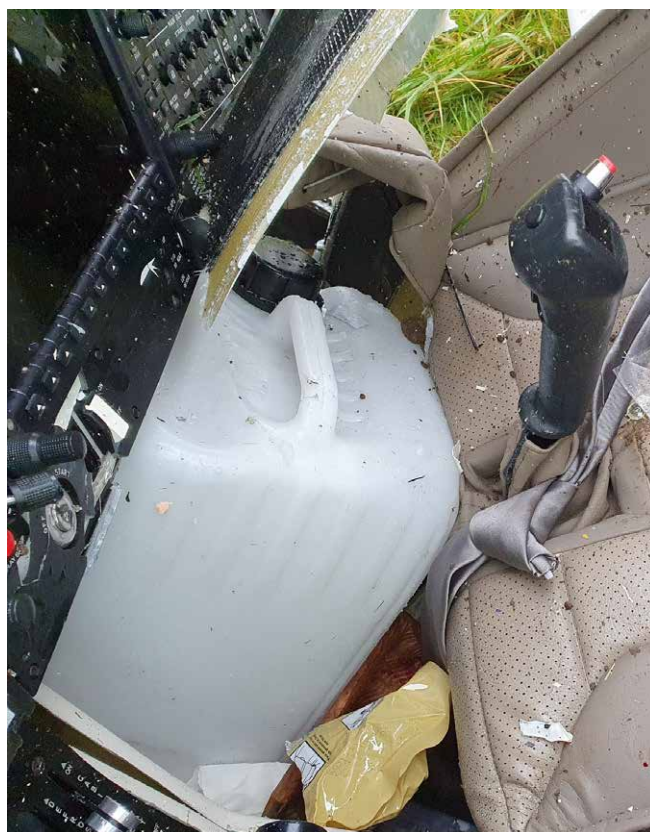
Figure 2

Images of the aircraft taken after the accident show the de-icing fluid container positioned in the footwell of the front right seat (Figure 2). Once removed, this container was found to have been punctured on the lower part of its forward face (as found) and on the base adjacent to the forward face damage (Figure 3).

Container as found in wreckage (used with permission)

These features indicate that the container had been positioned in the footwell in an upright position prior to the accident. The damage is consistent with the container moving forward during the accident, into the seat rudder pedal adjustment rail. This led initially to the forward face of the container being breached, followed by damage to the base of the container as it rode up over the rudder pedal adjustment rail. A scuff mark (Figure 4) was also identified on the top left surface of the container. This indicated that the container moved underneath the instrument panel during the impact sequence, providing additional confirmation that the container was upright during the accident, as the top surface would not have been scuffed if the container was laid either horizontally, or at an angle.

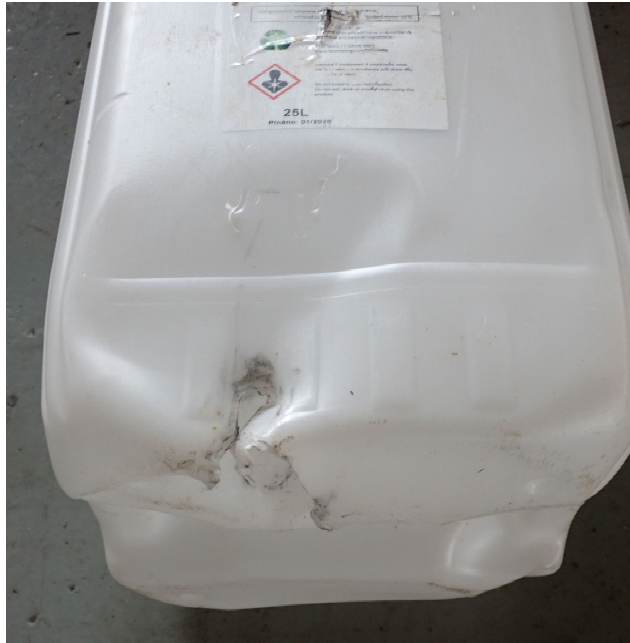
Figure 3

Lower forward face of container recovered from footwell of aircraft

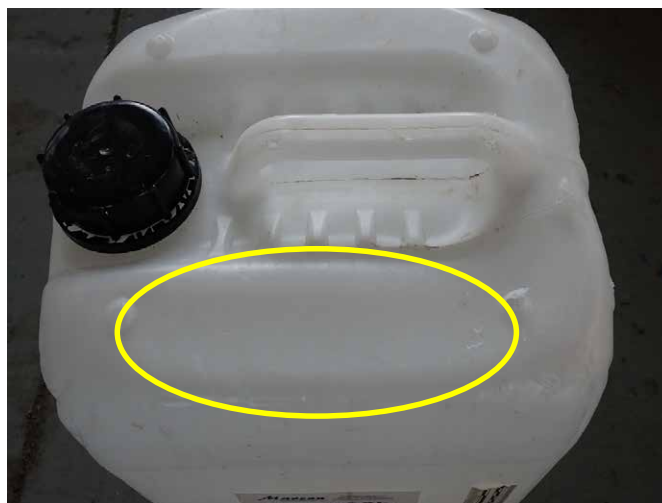
Figure 4

Scuff on upper front surface of container

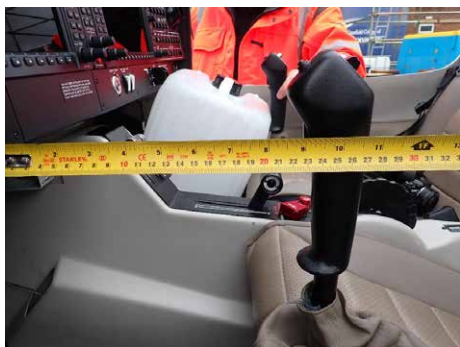
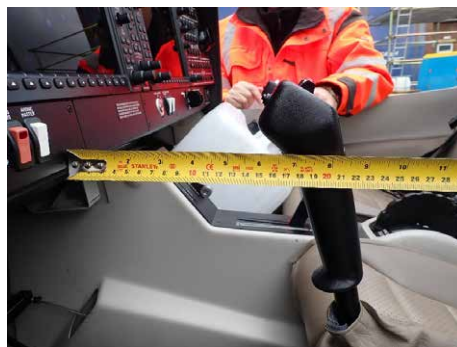
Figure 7

Container upright

Container at an angle

Control stick position measurements

This demonstrated that with the container in the upright position the control stick could not be moved forward of the control neutral point, and only slightly forward of the neutral point with the container lying at an angle with its base as far forward as possible (Figure 8).

The AAIB investigation found that during the accident flight the de-icing fluid container placed in an upright position in the front right footwell would have caused a significant restriction in the forward movement of the control stick at takeoff. It is possible that the absence of full and free movement was masked, as contact with the container was probably with the base, rather than the top, of the control stick. This might have given the impression that the stick had reached its natural full forward position, unrestricted by the container.

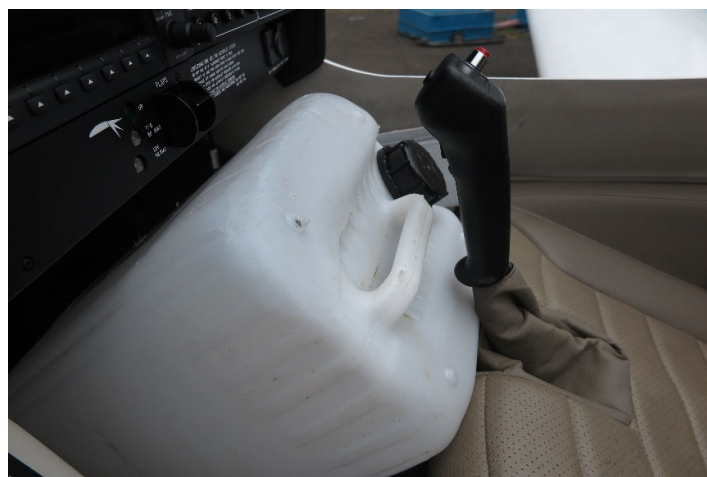
**Figure 8**

De-icing fluid container positioned at an angle with its base in contact with the rudder pedal adjustment rail

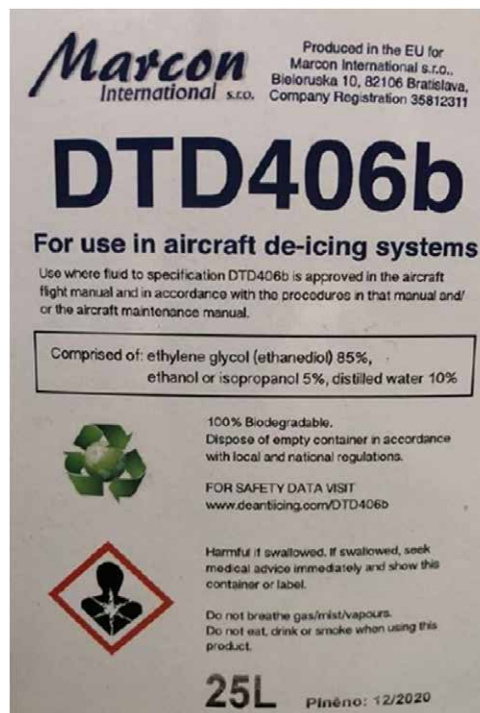
Figure 14

Each container (Figure 13) had a label affixed (Figure 14). The label stated the contents as DTD406b de-icing fluid consisting of 85% ethylene glycol (ethanediol), 5% ethanol or isopropanol, and 10% distilled water. It did not carry a UN number, but did carry markings and wording identifying that gas, mist and vapours should not be inhaled, nor the fluid ingested. It also provided a web address for safety data which, when tried, did not exist.

Label affixed to each container of de-icing fluid

- The flashpoint of Marcon DTD406b was stated in the SDS as being in excess of 110°C. Flashpoint is used as a primary indicator in the classification of flammable liquids, with only those with flashpoints below 60°C considered flammable. Given the much lower flashpoints (ca 54°C) for similar de-icing formulations, the stated value appears inconsistent. It was also noted that as Marcon DTD406b formulation may contain either ethanol or propanol-2-ol, it would be expected that the flashpoint would vary between batches depending on which is used.
- Additional documentary evidence showed that dilute (2-5% by volume) solutions of propanol-2-ol in water give rise to flashpoints in the region of 50-65°C, further indicating that the Marcon DTD406b had been incorrectly classified.

In conclusion the report found that, in line with similar de-icing products, Marcon DTD406b should be classified as a flammable liquid and thus be regarded as dangerous goods for the purposes of both transport and storage.

The AAIB investigation sought specialist advice to determine whether Marcon DTD406b should be considered a dangerous good and, whilst the result was not definitive, it is likely the fluid had been inappropriately labelled. This could present a hazard to those using, transporting or storing the fluid. It also presented a hazard to those coming into contact with it in emergency situations such as this accident.
