# Aviation Investigation Final Report

<b>Location:</b>	Marana, Arizona	<b>Accident Number:</b>	WPR21LA145
<b>Date &amp; Time:</b>	March 28, 2021, 14:28 Local	<b>Registration:</b>	N644SR
<b>Aircraft:</b>	CIRRUS DESIGN CORP SR22	<b>Aircraft Damage:</b>	Substantial
<b>Defining Event:</b>	Loss of engine power (total)	<b>Injuries:</b>	2 None
<b>Flight Conducted Under:</b>	Part 91: General aviation - Personal

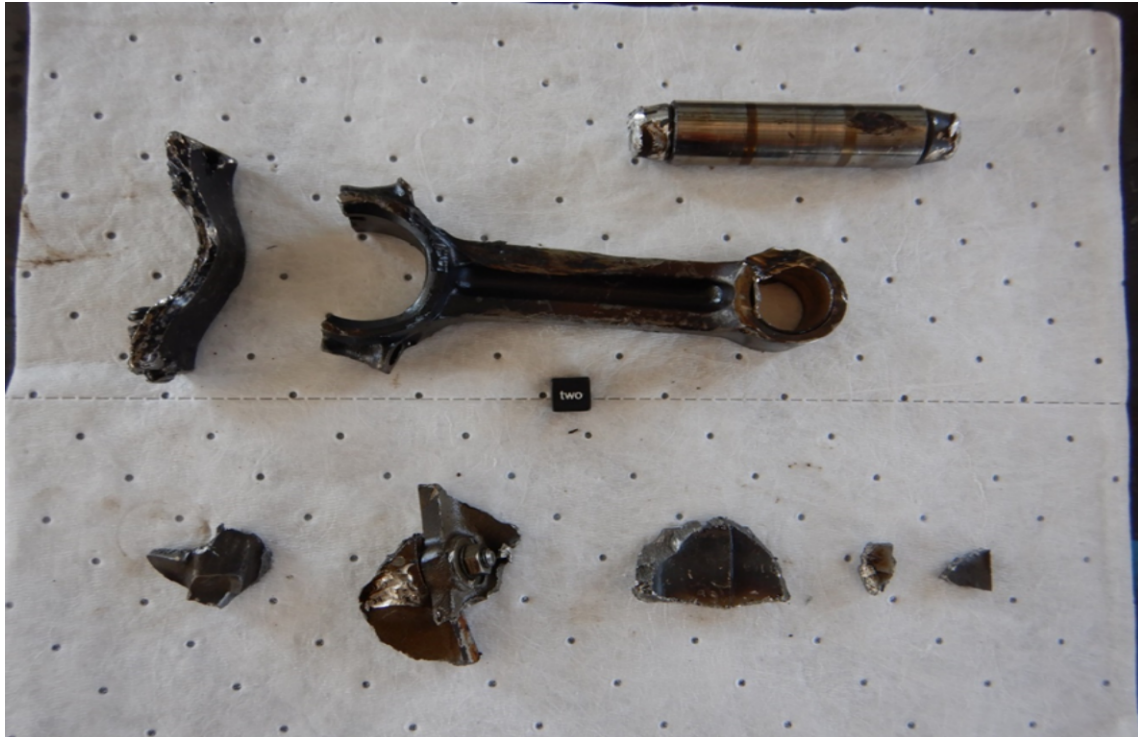
A postaccident examination of the engine revealed the No. 2 main bearing had rotated and the corresponding main bearing seal was not positioned properly in the saddle bearing support, which resulted in oil starvation and subsequent catastrophic failure of the engine. The reason for the bearing and bearing seal shift could not be determined due to the extent of the engine damage.

The No. 2 connecting rod and piston were separated from the crankshaft. The left half of the No. 2 main bearing was found rotated about 15° within the saddle area and overlapping the right half of No. 2 bearing. The left bearing half was shifted forward about 1/8 of an inch from its original position.

The corresponding main bearing seal was not positioned properly in the saddle bearing support, which resulted in a lack of oil lubrication and the discoloration of the connecting rod journal.

*Figure 2. No. 2 connecting rod, piston, crankcase pieces, and piston material.*

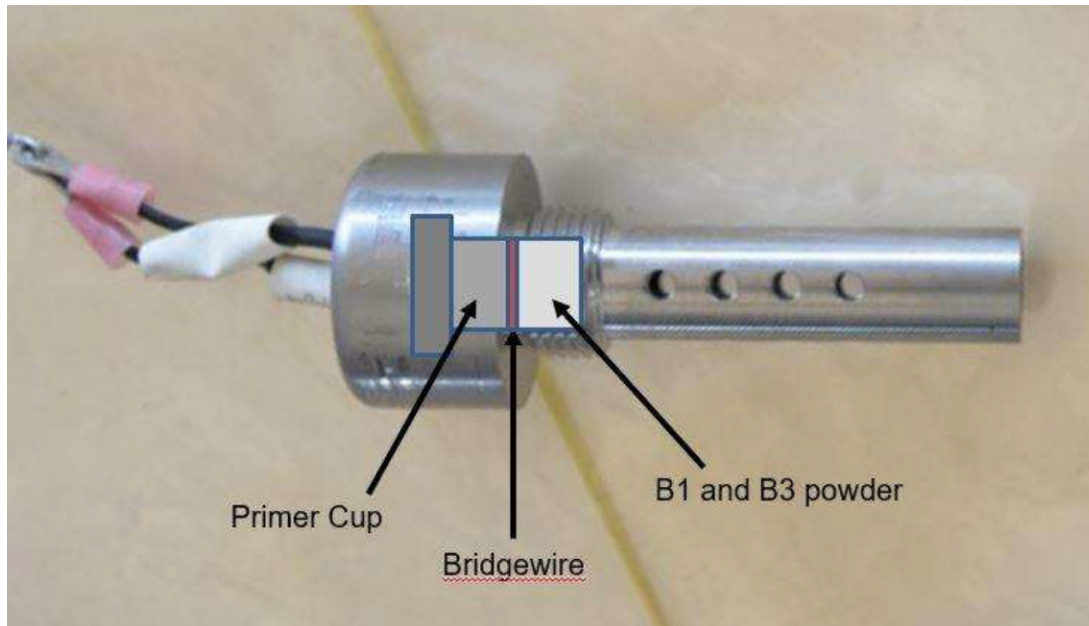
Figure 3. CAPS Igniter Assembly (Exemplar), courtesy Cirrus Aircraft

A postaccident examination of the Cirrus Airplane Parachute System revealed the chute had been packed properly but the rocket motor initiating device (squib) was inoperative. It was determined that the squib circuit was "open", and not "closed" as it should have been had the system not been fired. No other anomalies were initially identified that would have contributed to the system not firing.

The squib utilizes an internal bridge wire that heats up and ignites a primer charge, a Boron-Barium Chromate mixture (B1), within the squib. Activation of the B1 then ignites the output charge (B3) which subsequently ignites the  $\text{BKNO}_3$  pellets. The flame from the burning pellets exits the igniter through holes drilled in its sides and ignites the rocket propellant grains.

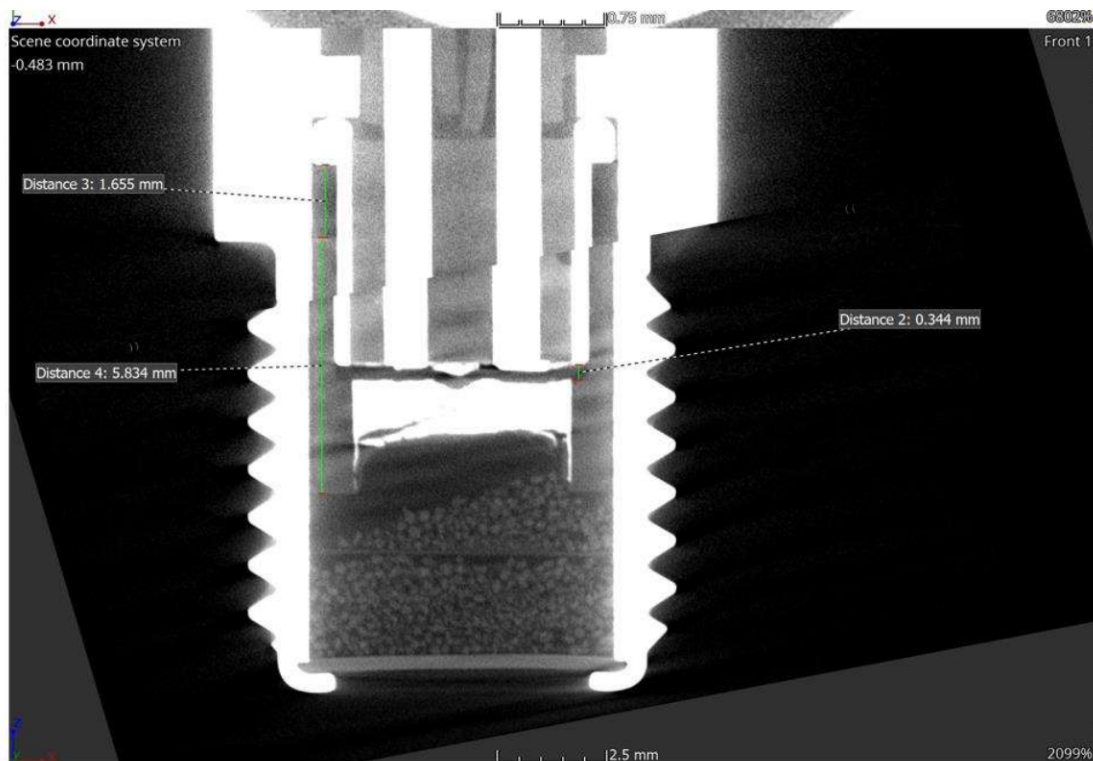
*Figure 4. CT Scan of squib showing B1 and B3 powder and void in cap.*

CT scans of the squib revealed the bridge wire was broken/activated (fused); however, the B1 did not ignite properly which subsequently prevented the  $\text{BKNO}_3$  from igniting. The specific reason for the failure of the B1 to properly ignite was not determined during this investigation; however, several possible factors were identified.

The ratio of boron versus barium chromate used in squib manufactured in 2015 was different and provided a different fuel/oxygen ratio.

It was noted that pieces of boron were larger in the B1 produced in 2015 which could have provided for a less homogenized mixture.

The accident squib recorded high moisture levels, although this may have resulted from when the squib was opened.

On June 9, 2021, Cirrus issued SB2X-95-27, "SNS SUBJECT SPECIAL PURPOSE EQUIPMENT – Replacement of CAPS Rocket Igniter." This service bulletin called for the removal of 25 squib assemblies produced from the same lot as the accident squib. Testing of the returned parts demonstrated additional "no-ignition" squibs from the same lot. On December 10, 2021, SB2X-95-27R2 was subsequently issued, which expanded the number of recalled squibs to 347. These squibs had been installed in SR20 and SR22 airplanes and were manufactured with the same batch of B1 as the accident squib.

In August 2022, testing on returned squibs resulted in another no-fire squib (SN 0416-3617). This serial number was outside the previously understood scope of suspect parts. As a result, SB20X-95-27R3 was issued on October 14, 2022, which expanded the scope of the previous SB by an additional 925 igniters.
