## Robin DR400-180 Electronic Ignition upgrade.

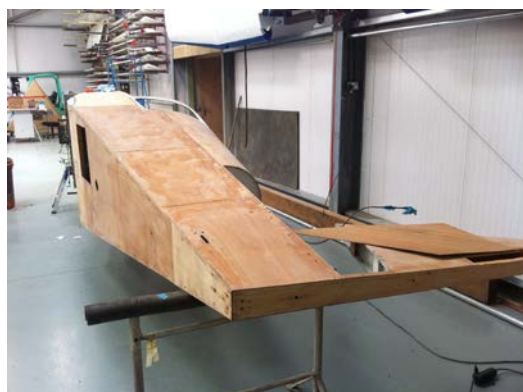
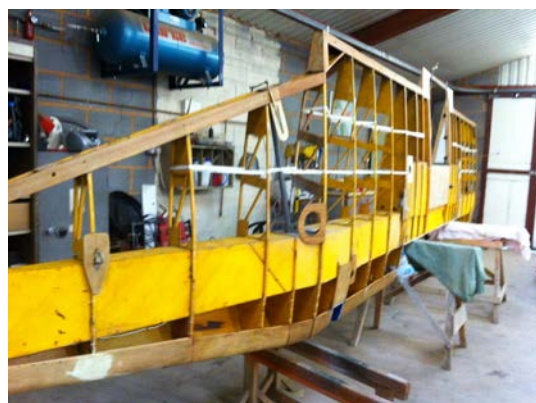
My current Aircraft has been with me for thirty years having had a history of flying club use and then an accident in France. It was repaired to quite a high standard by a U.K. company before I acquired it and looked very nice however after 25 years of flying some issues with the rebuild became apparent with the aircraft underperforming the flight manual numbers by about 4-5 Kt in the cruise. The paint finish looked like glass but was thickly applied and this added considerable weight and eventually started to crack that was my final motivator for the re-build along with the lack of rib stitching over spar that allowed the fabric to bulge up in the cruise that I suspected was the reason for the missing 4-5 Kt.

Substantial work was undertaken that I won't bore you with the details but you will get the idea from the photos save to say only a few bits of wood needed replacing and the total lack of rib stitching across the spar box was corrected.
