Cessna Centurion Wing Structural Assessment

Beth Gamble

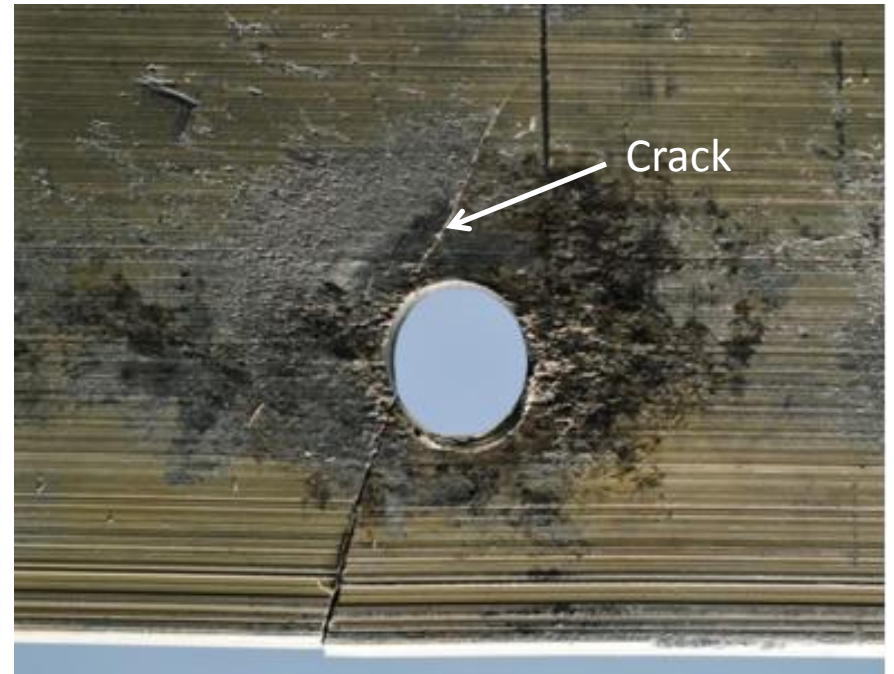
View of Spar Cap Lower Surface

210L with 5,750 hours

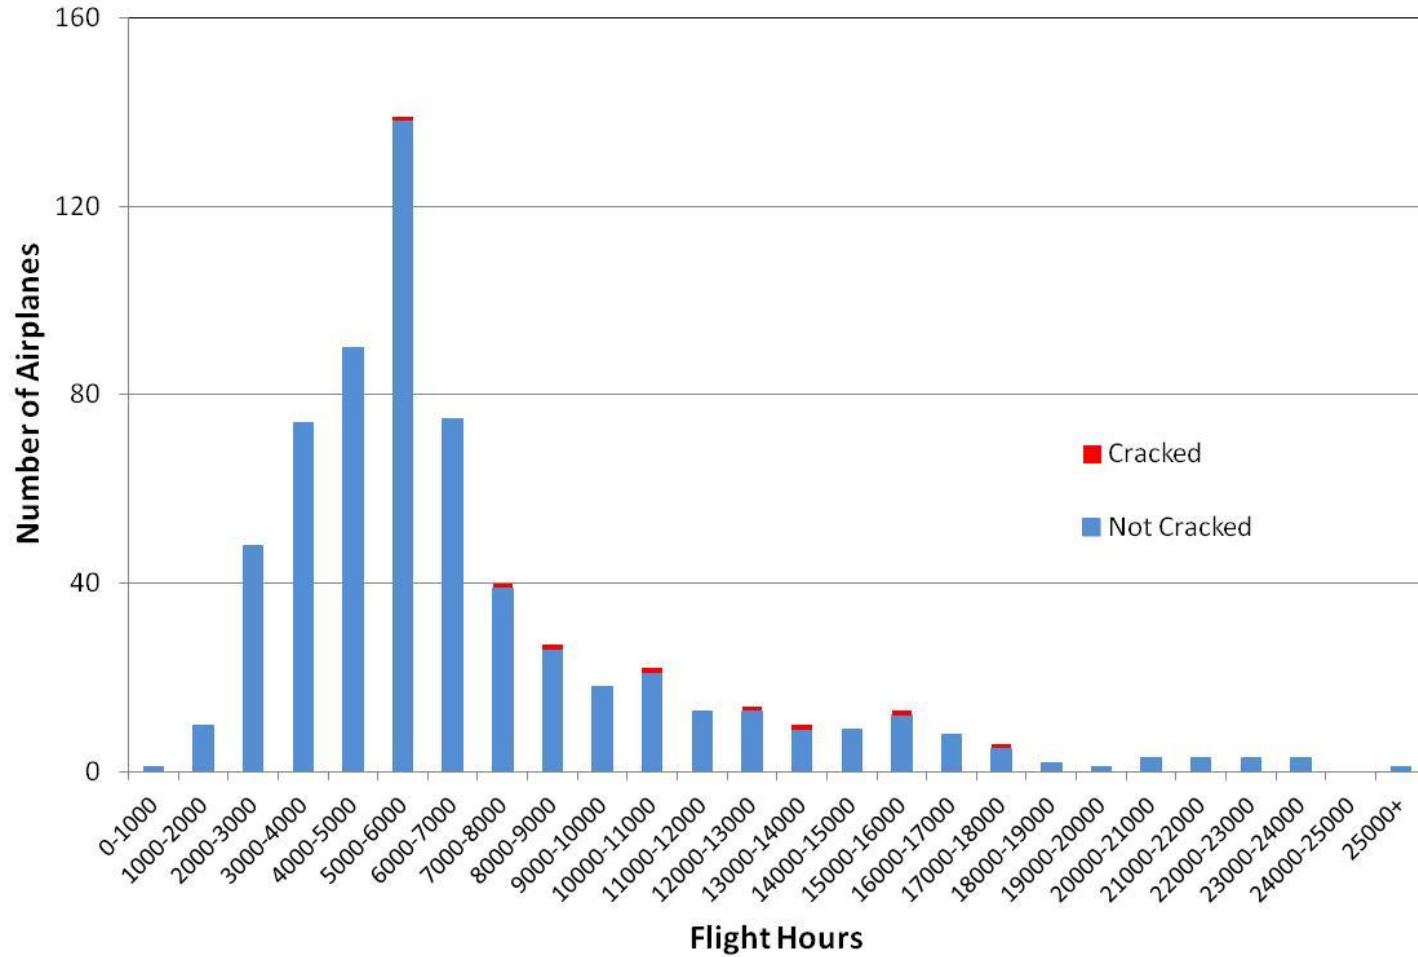
AD2012-10-04 Inspection Reports

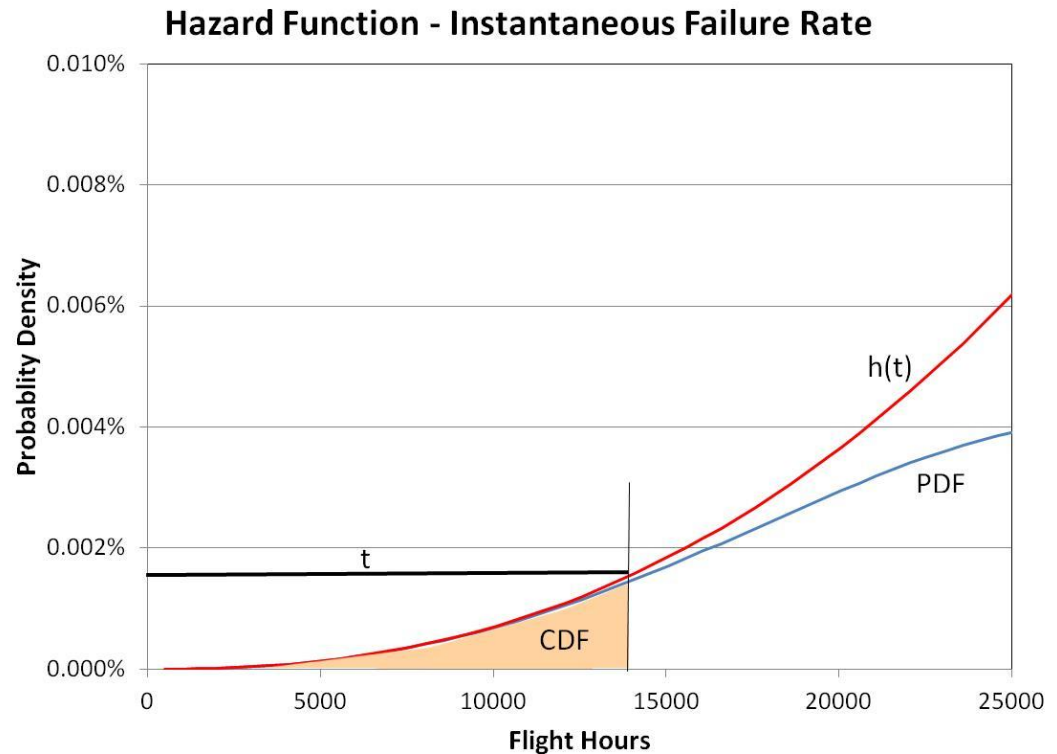
- Hazard function $h(t)$ used to determine instantaneous failure rate
 - Interpretation: Consider a single aircraft that found no failed spar at time t . The chances of having a cracked spar in a small interval $[t, t+dt]$ are then given by $H(t) \cong h(t) dt$

$$\text{Hazard Function } h(t) = \frac{PDF(t)}{1 - CDF(t)}$$

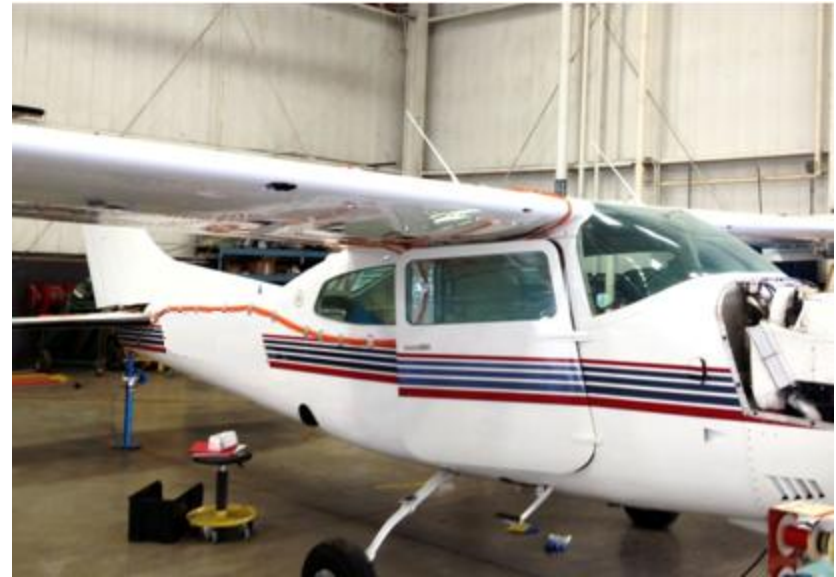
Flight Strain Test Airplane

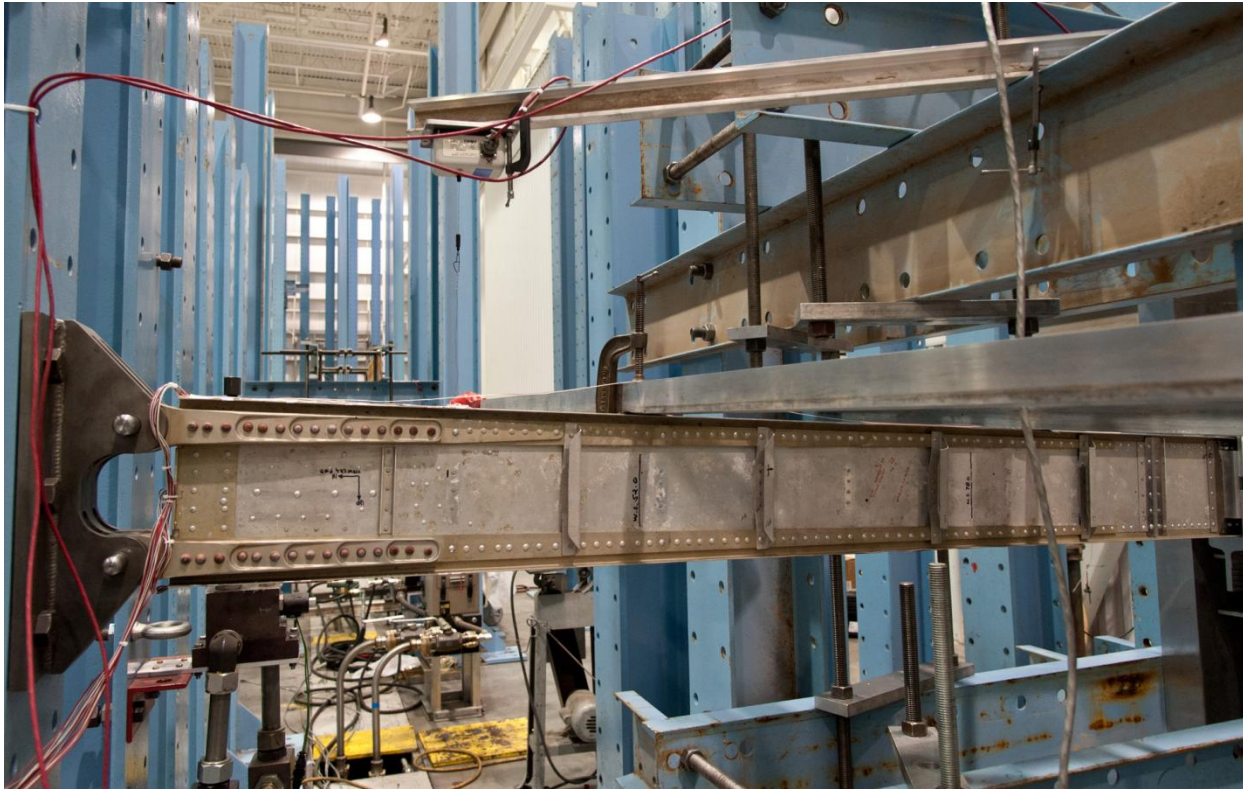
Residual Strength Testing – Test #1

Model 210 Wing Spar Assembly

- Testing conducted to determine if a 2014-T6511 spar cap has sufficient residual strength to hold limit load with a crack present
 - Model 210 wing spar assembly was obtained from a salvage yard
 - Test #1
 - Spar assembly (upper and lower caps plus web) was cyclic tested
 - Test #2
 - Section of spar cap with natural crack was placed into MTS machine and loaded to ultimate load

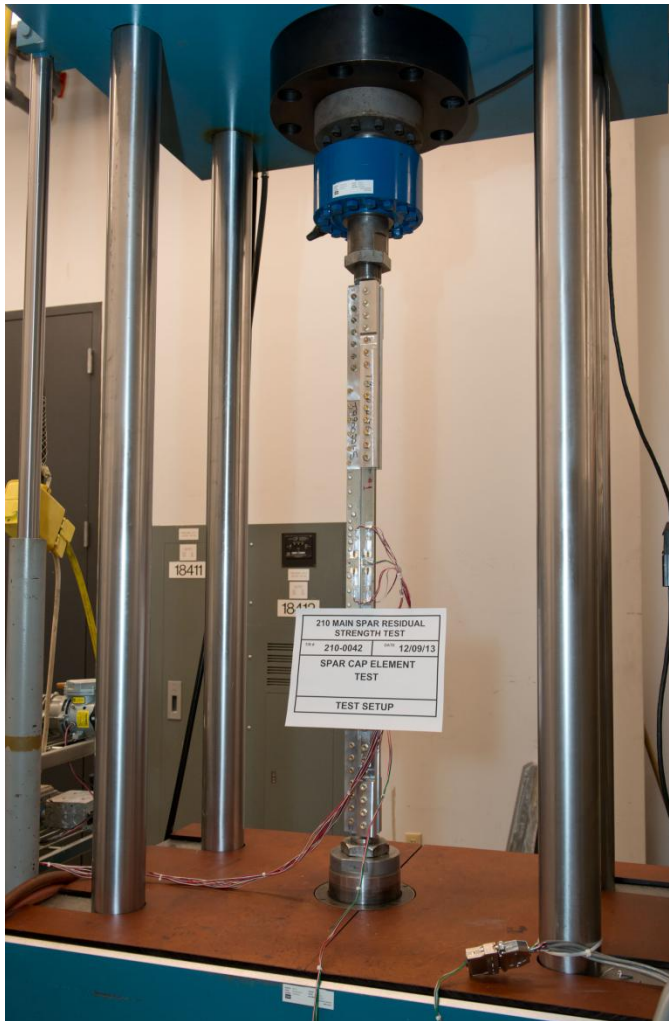
Test Setup
