Air transportation safety investigation report A21P0001

Loss of control

Mooney M20F, C-GYGN

Vicinity of Upper Kananaskis Lake, Alberta

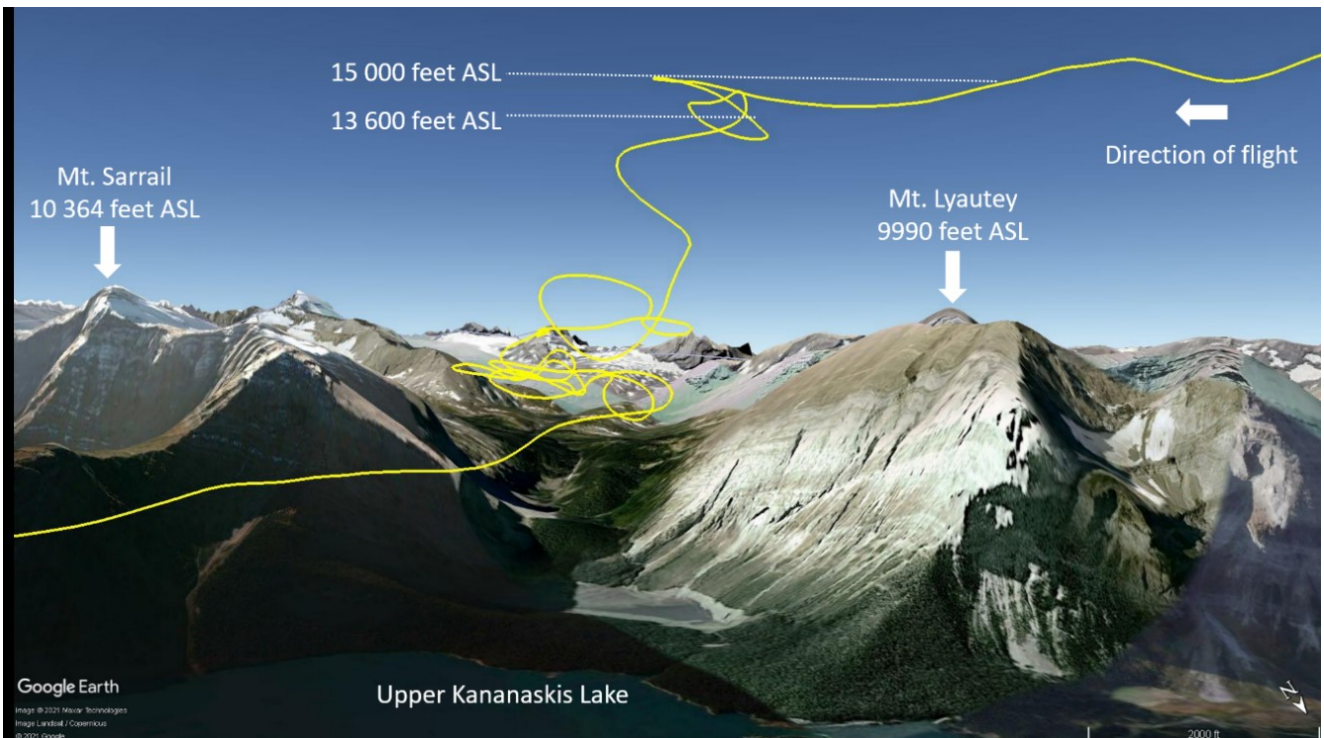
The pilot was able to see the terrain below as the aircraft descended through approximately 8500 feet ASL and control of the aircraft was regained at approximately 8100 feet ASL. At the time, the aircraft was in the Kananaskis Valley, where nearby mountain peaks extended up to 10 364 feet ASL (Figure 2). Flight visibility at the time was approximately 1 statute mile (SM), and improved to 2–3 SM as the pilot descended to approximately 7500 feet ASL, while flying toward Upper Kananaskis Lake.

Figure 2. Aircraft's flight path during loss of control event derived from its global positioning system (Source: Google Earth, with TSB annotations)
