## ACCIDENT

<b>Aircraft Type and Registration:</b>	HPH Glasflugel 304 eS, G-GSGS	
<b>No &amp; Type of Engines:</b>	1 LZ Design D.O.O FES-HPH-M100 brushless electric motor	
<b>Year of Manufacture:</b>	2016 (Serial no: 059-MS)	
<b>Date &amp; Time (UTC):</b>	10 August 2017 at 1121 hrs	
<b>Location:</b>	Parham Airfield, West Sussex	
<b>Type of Flight:</b>	Private	
<b>Persons on Board:</b>	Crew - 1	Passengers - None
<b>Injuries:</b>	Crew - None	Passengers - N/A
<b>Nature of Damage:</b>	Fire damage to FES <sup>1</sup> batteries and FES battery compartment	
<b>Commander's Licence:</b>	British Gliding Association Gliding Certificate	
<b>Commander's Age:</b>	55 years	
<b>Commander's Flying Experience:</b>	314 hours (of which 25 were on type) Last 90 days - 9 hours Last 28 days - 7 hours	
<b>Information Source:</b>	AAIB Field Investigation

## Synopsis

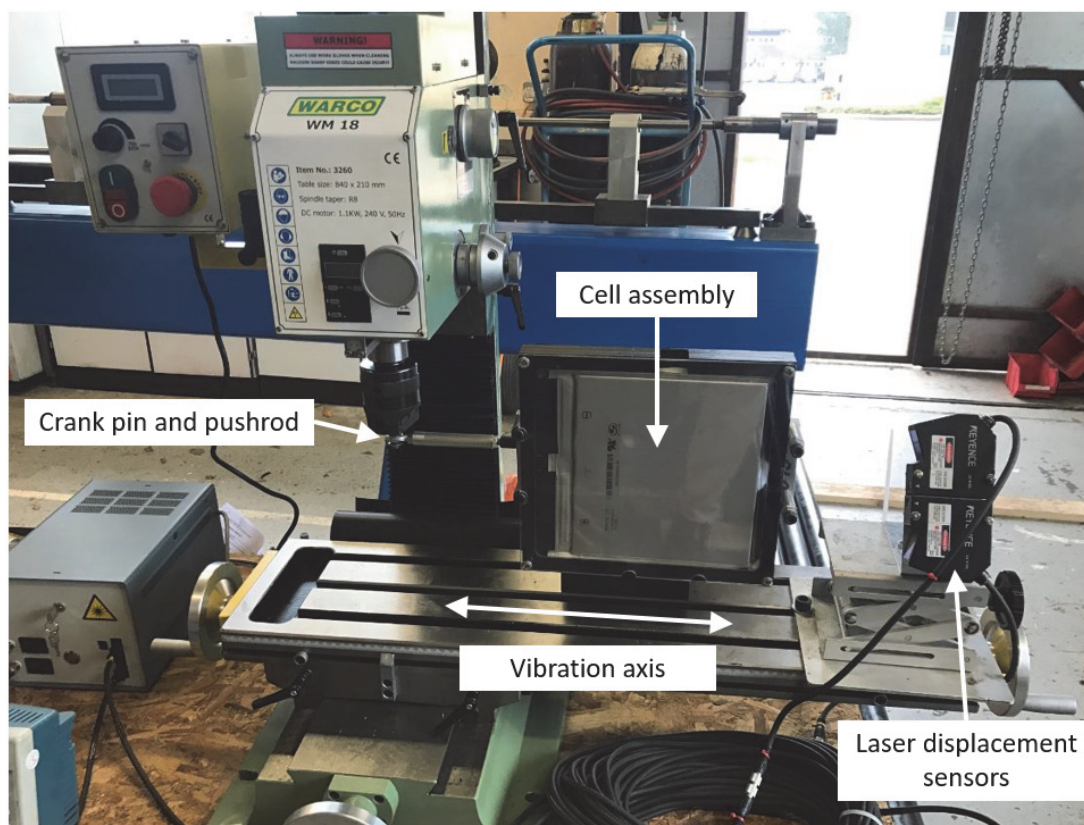
**Figure 15**  
Cell vibration testing equipment

The cell fixture was mounted on a milling machine bed on a linear bearing allowing displacement along the machine bed axis only (Figure 15). The cell fixture was connected via a pushrod to a crank pin mounted in a boring bar head in the milling machine spindle. The eccentricity of the driving crank pin was adjusted to achieve the desired peak-to-peak amplitude displacement of the cell fixture of 2.5 mm for the frequency range 5 – 15 Hz, and 1.0 mm for 15 – 40Hz<sup>8</sup>. Using the variable spindle speed on the milling machine, the cell fixture could be vibrated across a frequency range of 1 – 40 Hz. Laser displacement sensors were used to measure the relative displacements between the cells within the cell fixture.
