This Airworthiness Bulletin (AWB) is a compilation of information contained in Airworthiness Advisory Circulars (AAC), Service Bulletins (SB), Service Difficulty Reports (SDR) and Advisory Circulars (AC) and will be revised from time to time to incorporate new magneto defects.

Magneto Defects

AWB 74-005 Issue : 3
Date : 20 October 2014

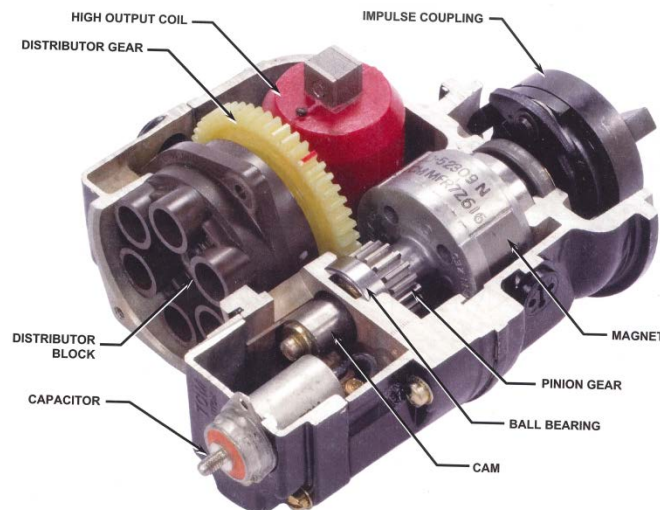
Figure 1 – General Arrangement of 20/200 Series Magneto (Sourced from TCM Aviation Technician Advanced Training Program)
