ACCIDENT

Aircraft Type and Registration:	DA 40 NG, G-CTSB
No & Type of Engines:	1 Austro E4-A piston engine
Year of Manufacture:	2015 (Serial no: 40.N283)
Date & Time (UTC):	12 December 2020 at 0926 hrs
Location:	Cranfield Airport, Bedfordshire
Type of Flight:	Aerial Work
Persons on Board:	Crew - 1 Passengers - None
Injuries:	Crew - 1 (Serious) Passengers - N/A
Nature of Damage:	Aircraft destroyed
Commander's Licence:	Commercial Pilot's Licence
Commander's Age:	23 years
Commander's Flying Experience:	1,229 hours (of which 779 were on type) Last 90 days - 70 hours Last 28 days - 33 hours
Information Source:	AAIB Field Investigation

Synopsis

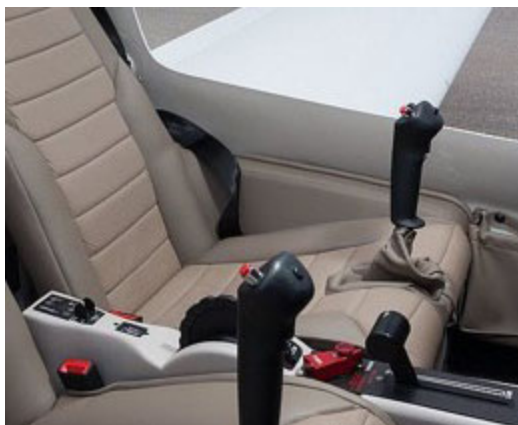
Figure 1

The DA 40 NG is a four-seat, low-wing, single-engine aircraft with a fixed tricycle undercarriage. It is fitted with dual controls and a control column located in a cut-out in the base of each front seat (Figure 1). The rudder pedals have an adjustment mechanism fitted to allow them to slide backwards or forwards along a rail to accommodate different pilot leg lengths. Aircraft trim can be adjusted by either an electronic switch on the flying controls or a trim wheel situated on a console between the front seats.

Flight control stick DA 40 NG

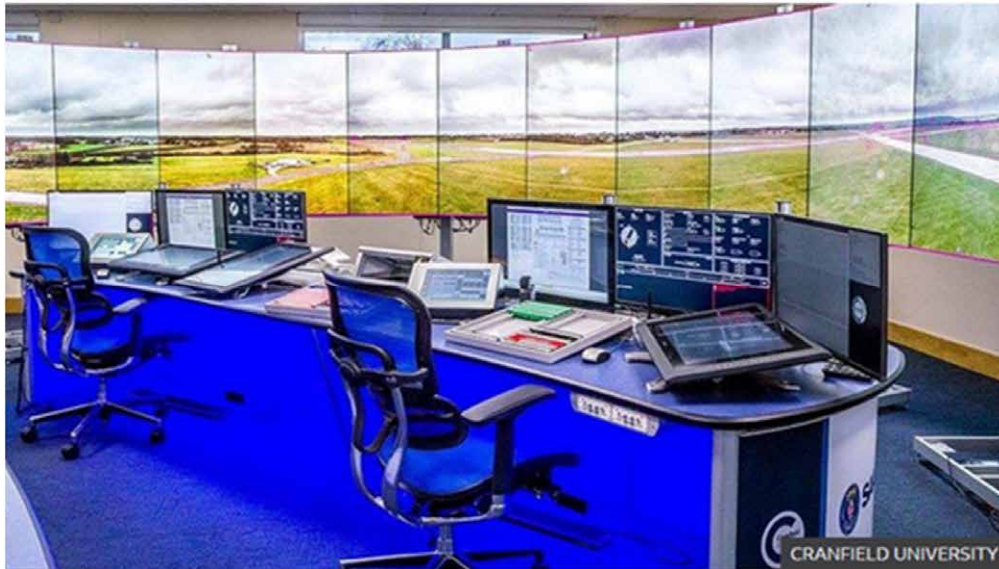
Figure 12

The DATCC used cameras located at the runway mid-point to cover a 360° view of the airfield, which was displayed to controllers on 14 large monitors within the control centre (Figure 12). The introduction of the DATCC had resulted in few operational changes for the controllers, and none concerning the initiation and management of an emergency response. The controllers reported that their view of the runway and taxiway surfaces was better due to the location of the cameras, but it was acknowledged that the image presented could suffer at range due to pixilation. Additionally, weather conditions could not be reliably assessed using the cameras, as there was a tendency for the visibility to look better than it was. Therefore, 'out-of-the-window' meteorological observations were still required.

DATCC Cranfield (used with permission)
